THE GROUND-FAULT PROTECTION
BLIND SPOT:
A SAFETY CONCERN FOR LARGER
PHOTOVOLTAIC SYSTEMS
IN THE UNITED STATES

A Solar ABCs White Paper

January 2012

Bill Brooks
www.brooksolar.com

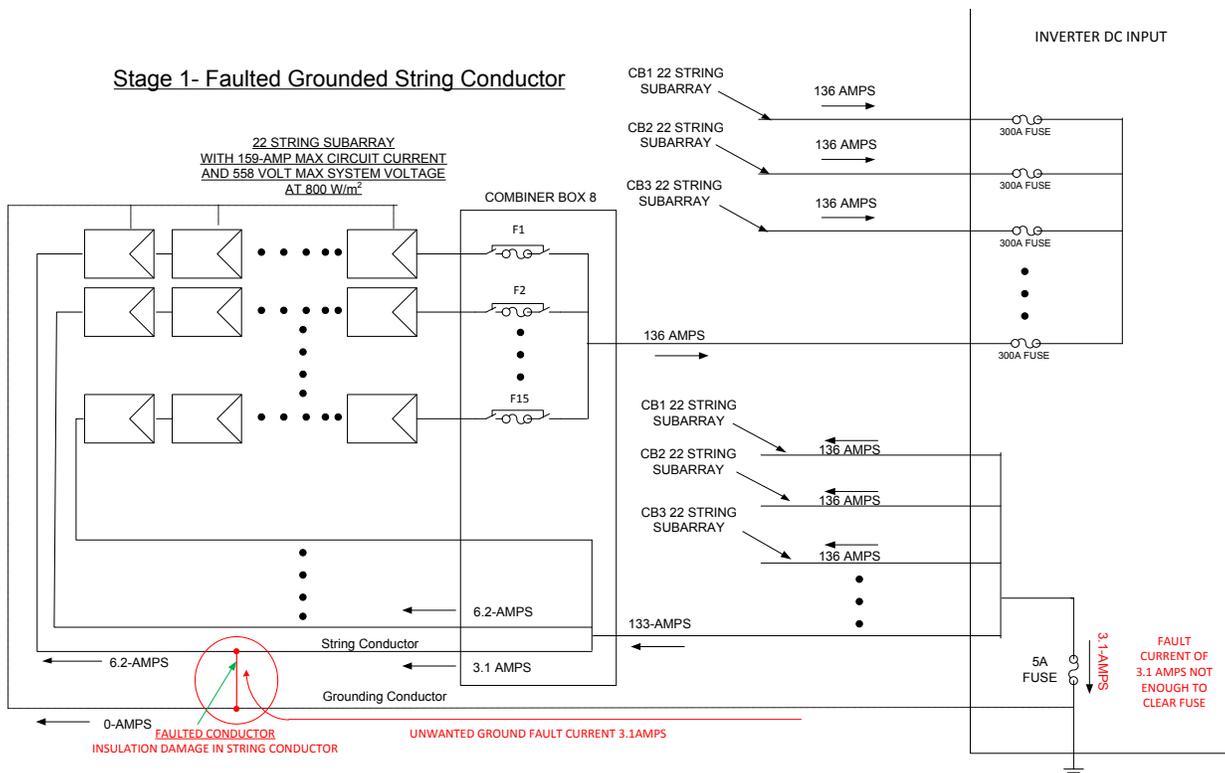
Figure 1: Ground-Faulted String Conductor, the Assumed First Fault—Bakersfield Fire

The evidence suggests that the ignition of the Bakersfield fire resulted from two faults occurring in two significantly different wire sizes in the PV array. The first fault was in a small grounded conductor. Failure to detect this first fault created the potential for the faulted grounded conductor to become part of a circuit for which it was not designed.

Physical evidence from the Bakersfield fire suggests that about 1,000 amps flowed through the faulted grounded conductor, a small unprotected 10 AWG wire. The wire insulation burned and ignited other fuel in the immediate vicinity. Because NEC installation requirements do not allow overcurrent protection devices in the grounded conductors of grounded PV arrays [NEC Article 690.13], full array current flowed unimpeded through the ground fault in the string-level wiring of the Bakersfield system.

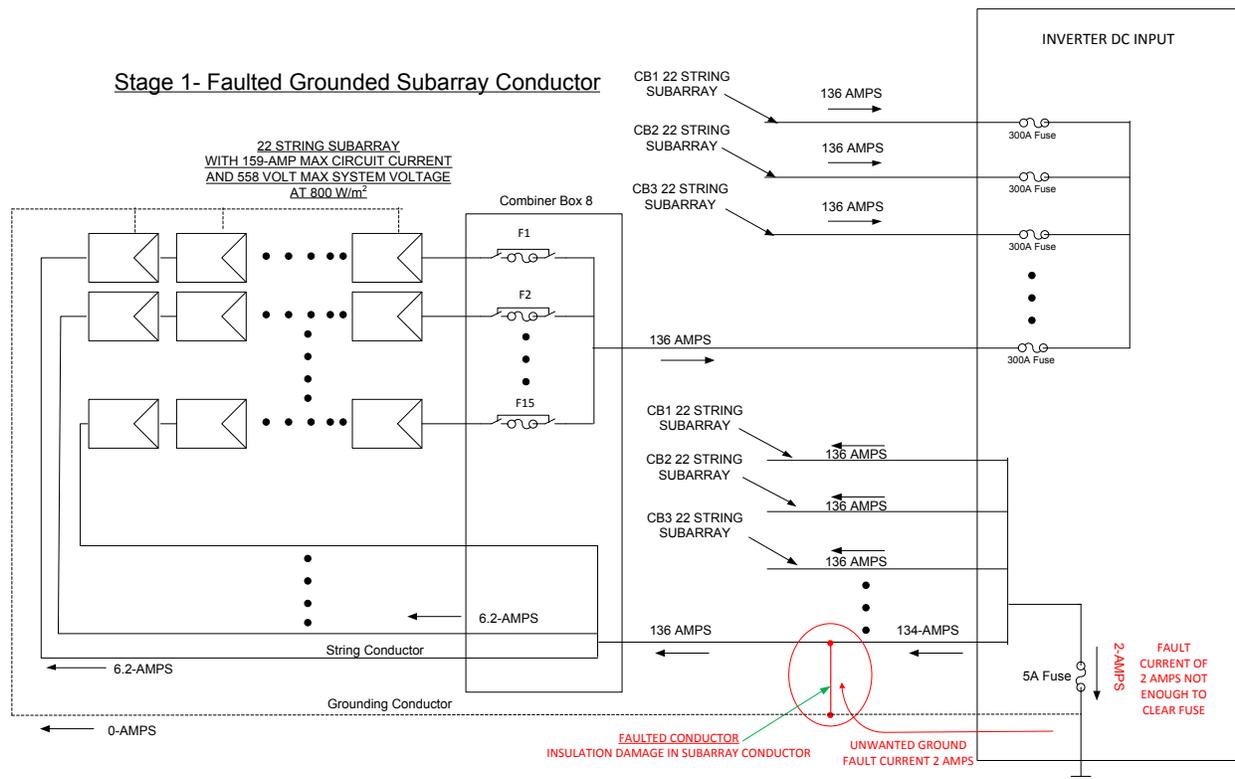
Figure 2: Ground-Faulted Subarray Conductor, the Assumed First Fault—Mount Holly Fire

The same scenario is suggested in the Mount Holly fire, but here the evidence indicates that both faults occurred in large combiner box feeder conductors. This was unexpected, because conventional wisdom assumes that a fault in a grounded large conductor would blow the ground-fault fuse and shut down the inverter. However, full

review of the Mount Holly fire suggests that even large grounded feeder conductors can be faulted and remain in the blind spot of the ground-fault protection device. Two months before the Mount Holly fire, maintenance inspection personnel photographed conductor insulation damage in two sections of the array that were later severely damaged in the fire. Although the inspectors were concerned that this damage would cause the ground-fault protection system in the inverter to shut the system down, they did not fully understand the threat of fire because so few fires have been reported.

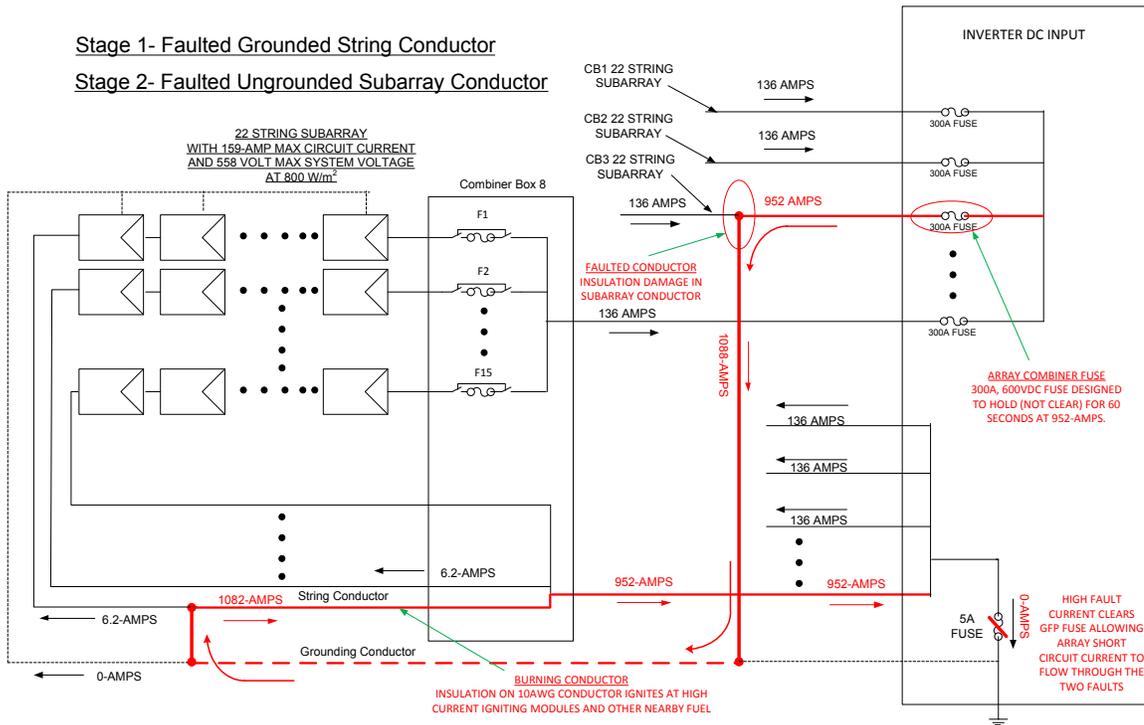
Figure 3 shows the second fault in a fire similar to the Bakersfield event. In this scenario, the short circuit current is forced through the small 10 American wire gauge (AWG) grounded string conductor, causing a conductor insulation fire. Figure 4 shows the second fault in a fire similar to the Mount Holly event, in which the array short circuit current is forced through the poor inadvertent grounding connection, causing an arcing fire.

A 500-kilowatt (kW) PV array can have more than 1,300 amps of available short circuit current, which can cause enormous damage during this short circuit condition. If the two connection points were intentionally made with terminations able to handle the current, there would be little if any hazard. Unfortunately, these connections are made with only incidental contact that can evolve dramatically into intense arcs with operating temperatures of more than 2,000°C. These arcs can jump gaps between metal parts up to six inches apart.

Figure 3: Second Ground-Faulted Conductor, Representative of the Bakersfield Fire

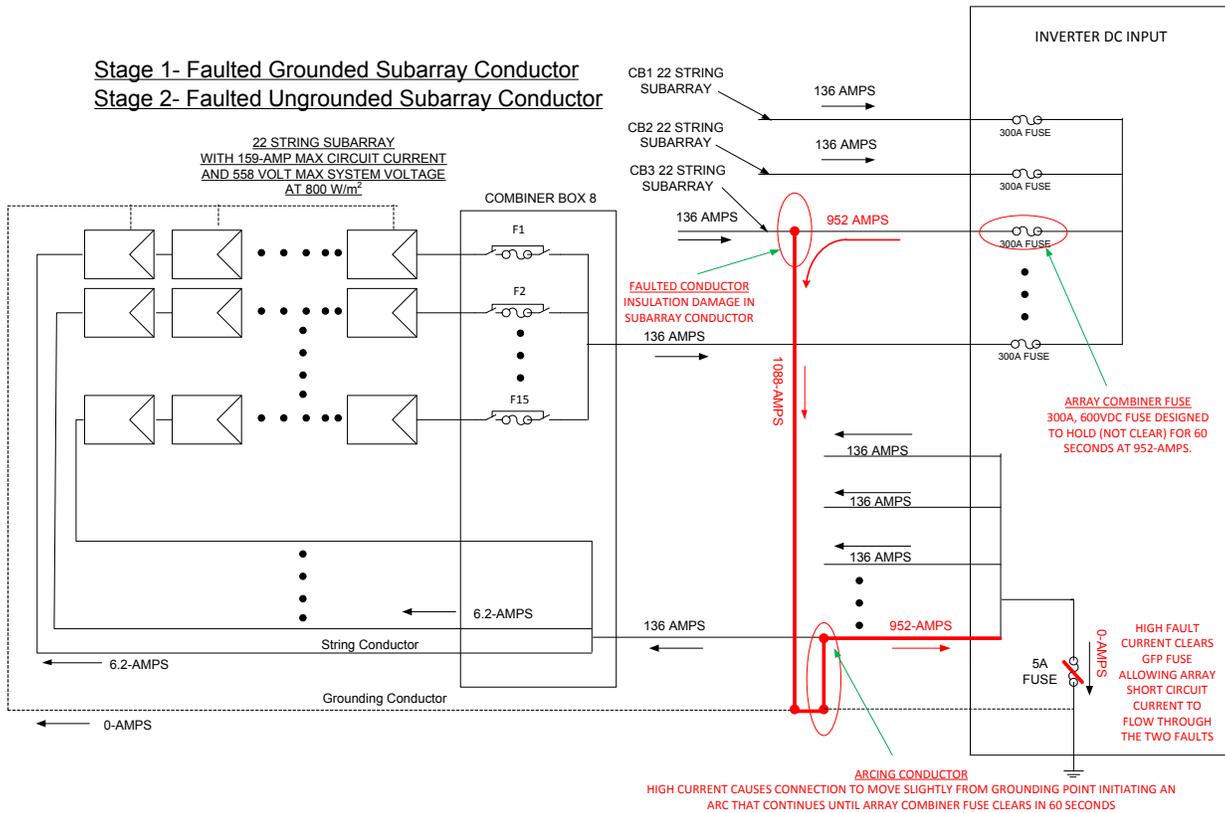
Figure 4: Second Ground-Faulted Conductor, Representative of the Mount Holly Fire
