# THE GROUND-FAULT PROTECTION BLIND SPOT: A SAFETY CONCERN FOR LARGER PHOTOVOLTAIC SYSTEMS IN THE UNITED STATES

**Bill Brooks, P.E.**  
Brooks Engineering

A Solar ABCs White Paper

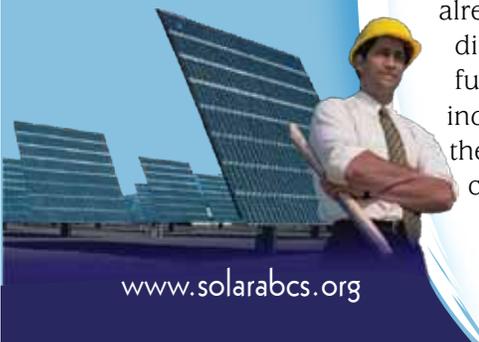
It appears that at some time before the ignition of the Bakersfield and Mount Holly fires, a ground fault in a grounded conductor occurred and was allowed to continue. In recent months, it has become obvious that faults on grounded conductors in PV arrays can be difficult to detect with the typical methods used in ground-fault protection equipment today. This is because the conductor is already grounded, so additional grounds on the conductor have less voltage differential to drive the current necessary to blow the protective ground-fault fuse. This condition can allow ground faults on the grounded conductor to exist indefinitely in a PV array, establishing a new “normal” condition that renders the ground-fault protection device unable to interrupt the second ground-fault current. More seriously, the activation of the ground-fault fuse in the event of an ungrounded conductor fault to ground actually helps to drive the fire event.
