Recent Considerations of New UL1703 Method

Dwayne Sloan

Recent Considerations - New UL1703 Method

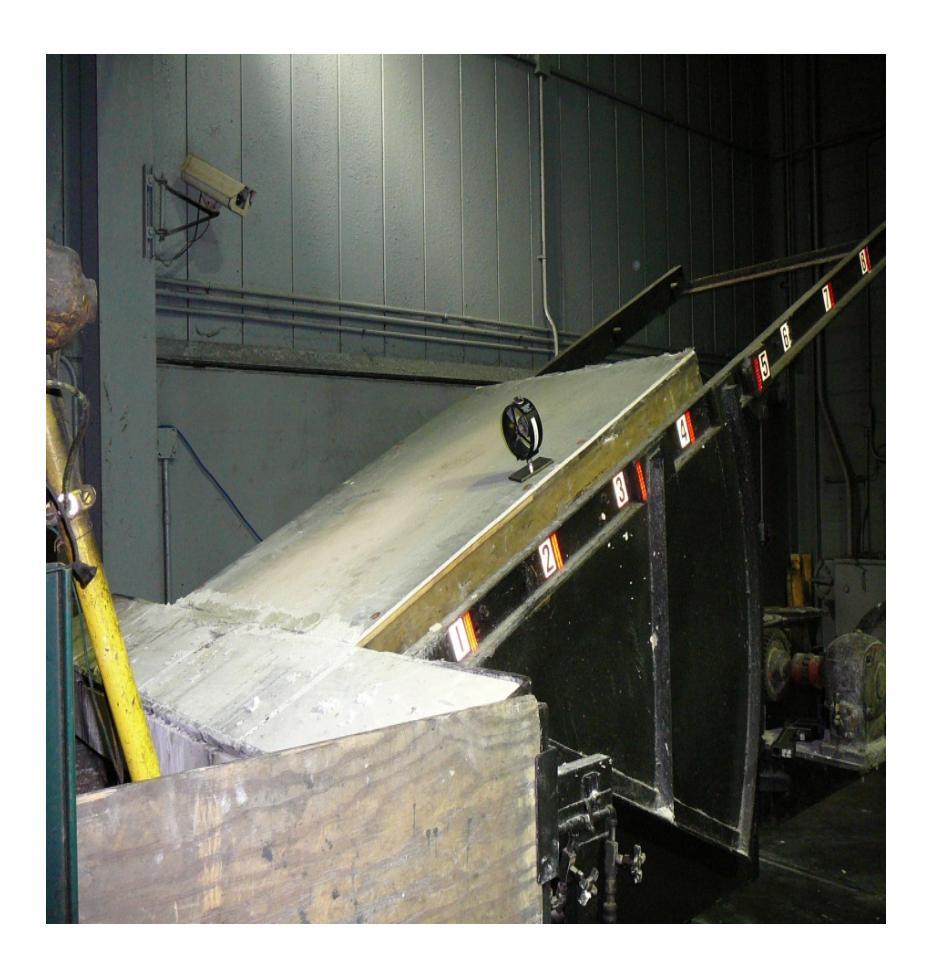
UL 790 Calibration

Measured Parameters:

- Airflow 12 mph
- Temperature 1400°F

Observed Parameters:

- Ignition Flame Length
- Ignition Flame Shape

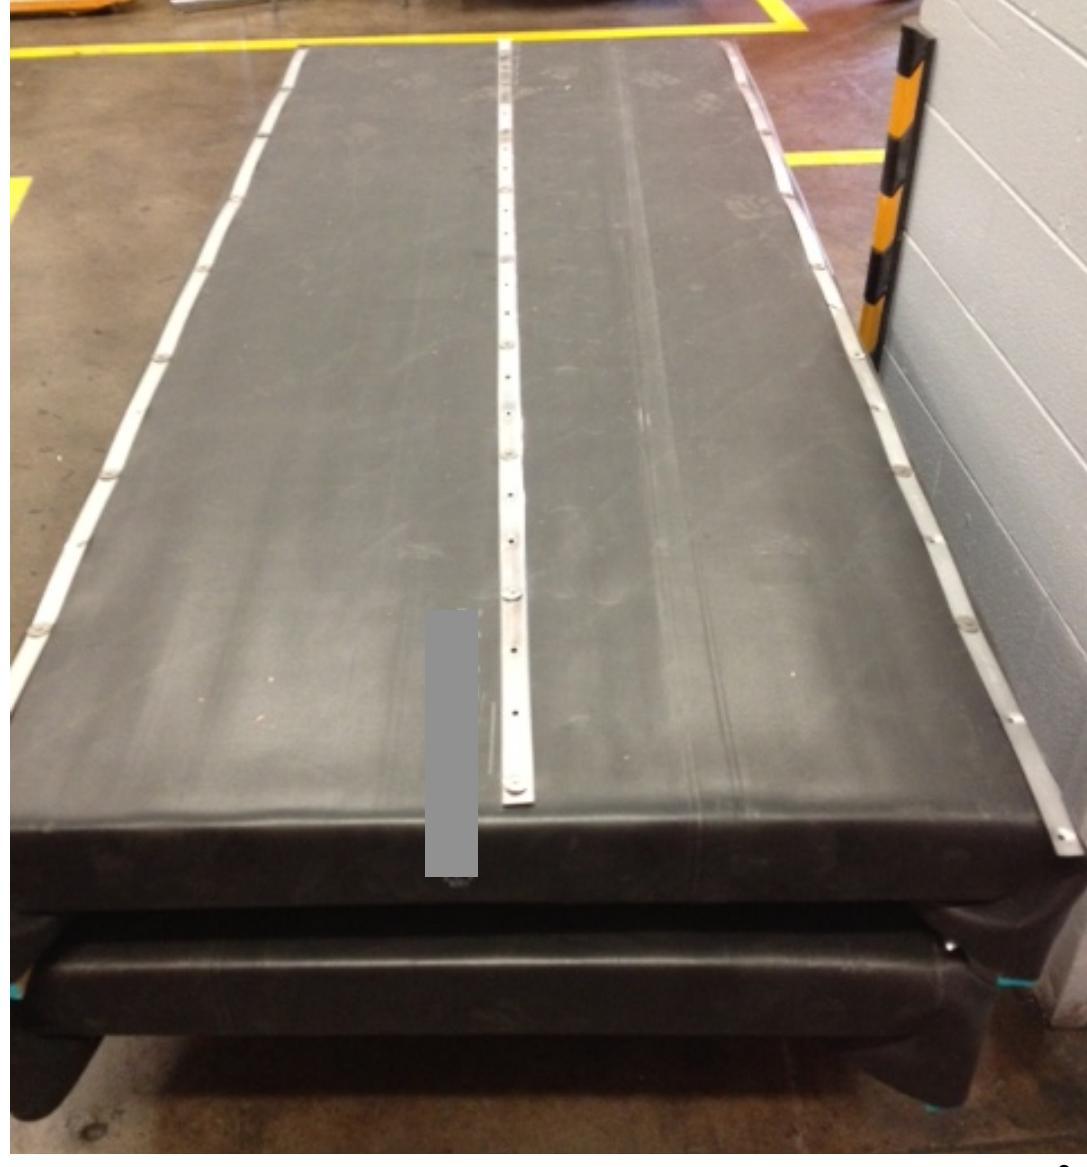
Example of Baseline Solution

Use of specific mounting procedure to lend greater confidence in results

Center batten bar on low slope membrane

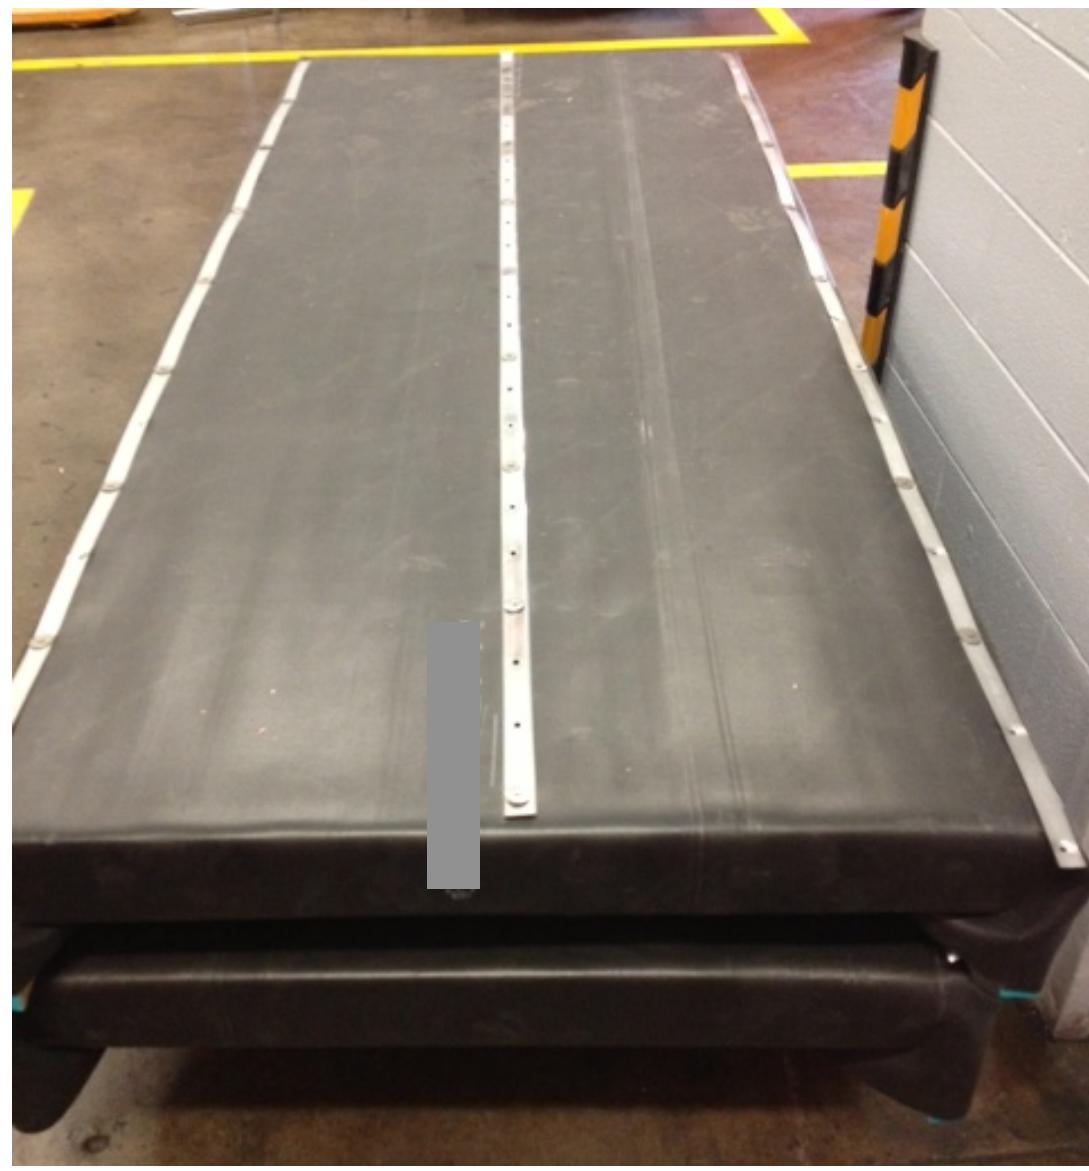
Example Baseline Solution

Multiple Tests -Promising Results

Test #	Flame Spread (ft)
1	4.75
2	4.25
3	4.5
4	5
5	5.75
Average (ft)	4.85
Std. Dev (ft)	0.58

91% Confidence Level of results between 4 - 6 ft.

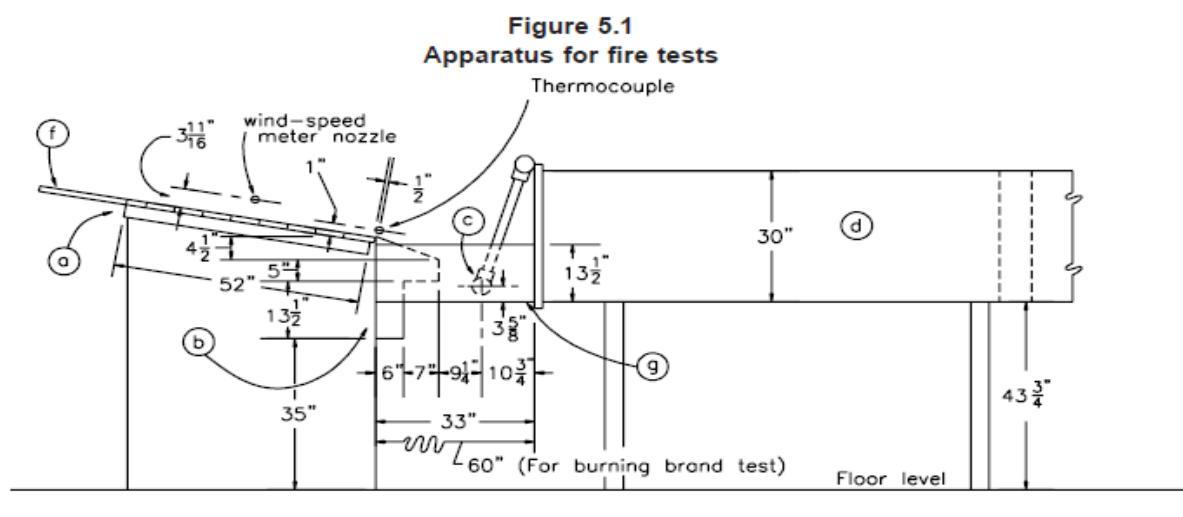
SIDE VIEW

UL 790 / 1703 Calibration Measurements

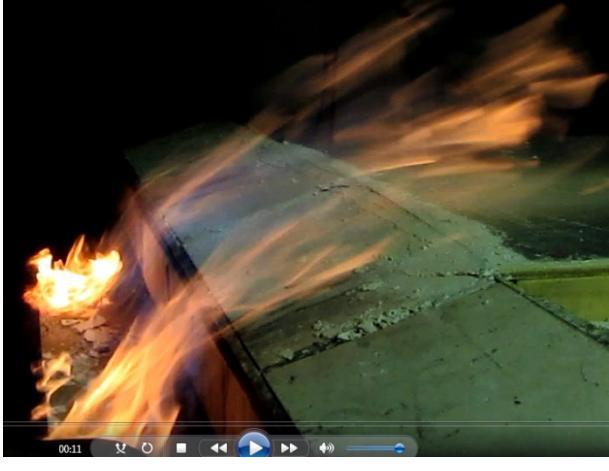
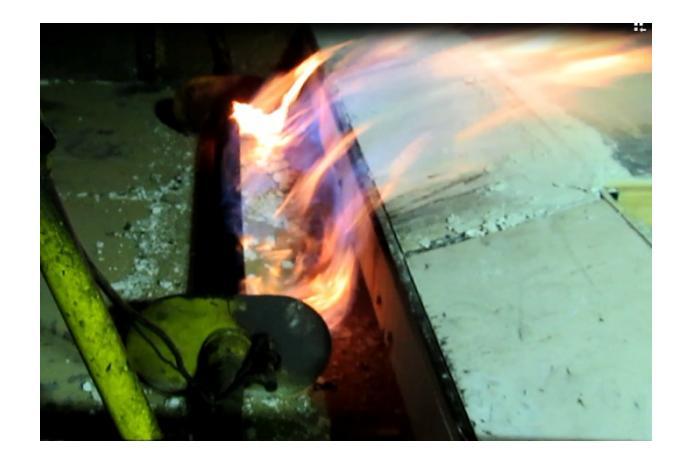
"Blue Flame" – Flame Type

With 12 mph airflow Premixed flame

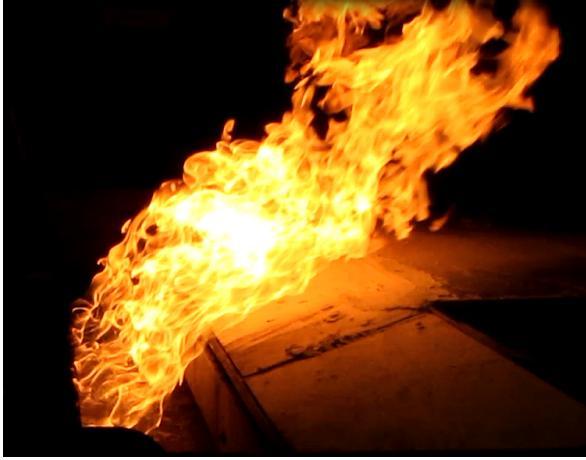
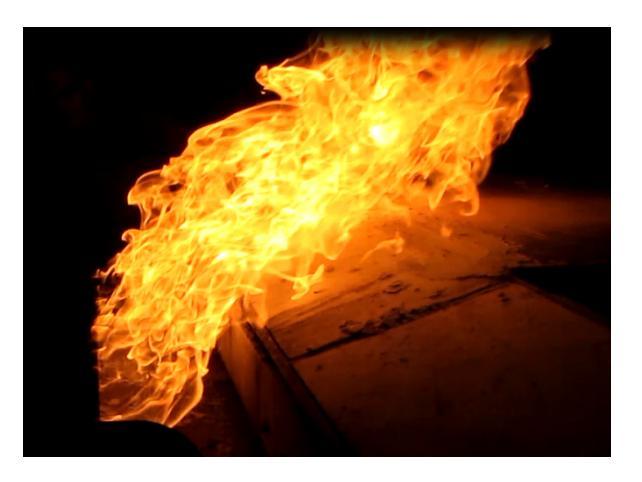
Without 12 mph airflow Diffusion flame

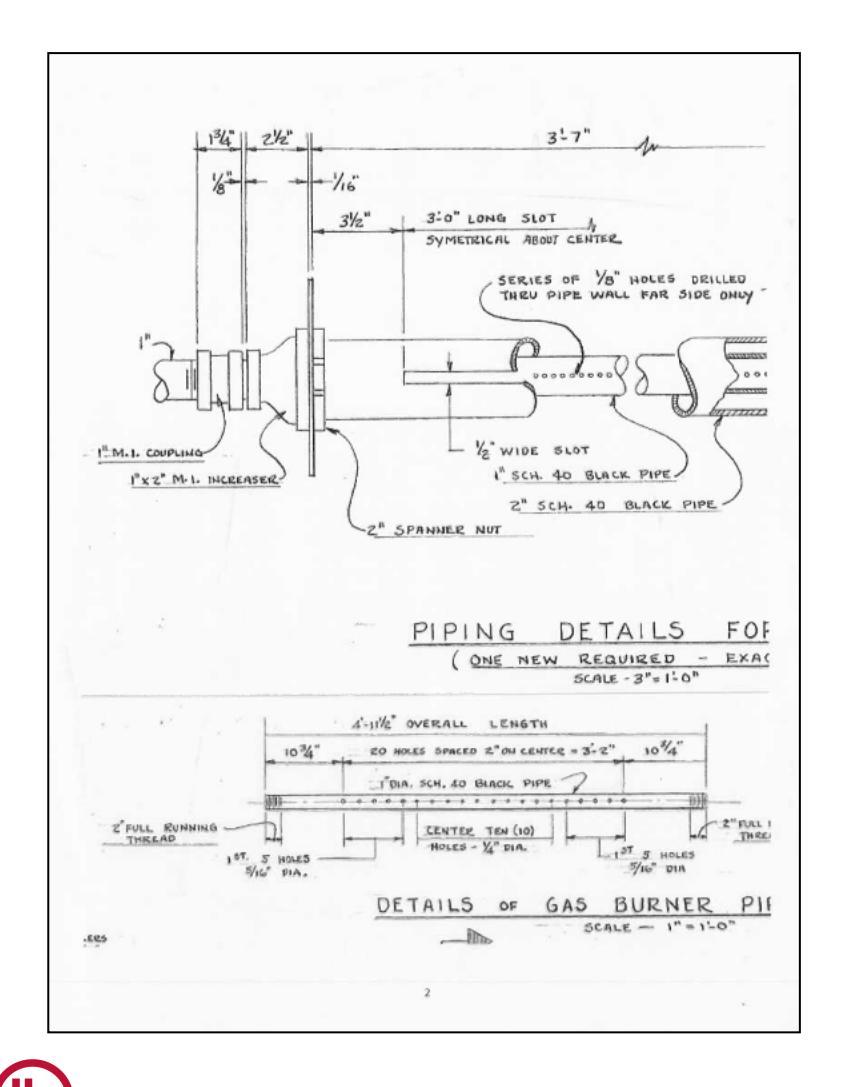
Ignition Source Burner

Unknowns:

- Inconsistent construction drawing details (inner pipe hole size)
- Pipe has not been inspected since installed ~ 60 years.
